# Hot Dip Galvanizing

The best  
protection  
inside  
and out

**galvanizers**  
ASSOCIATION OF AUSTRALIA

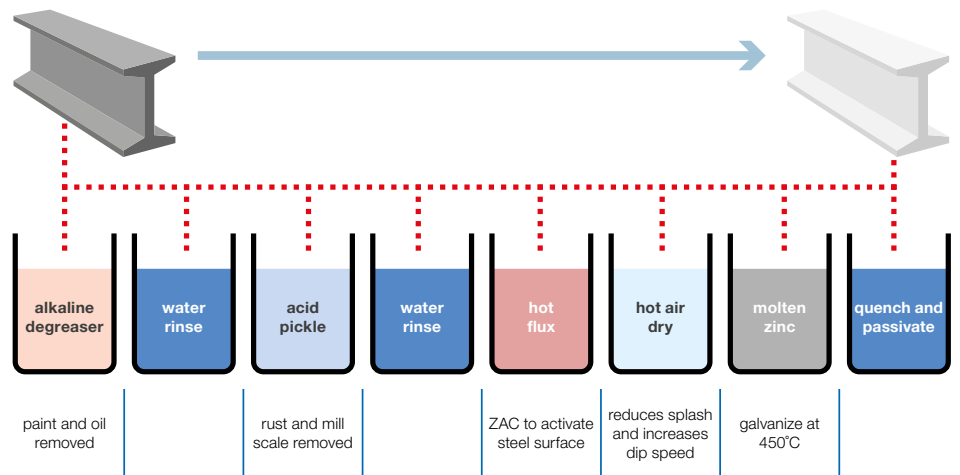
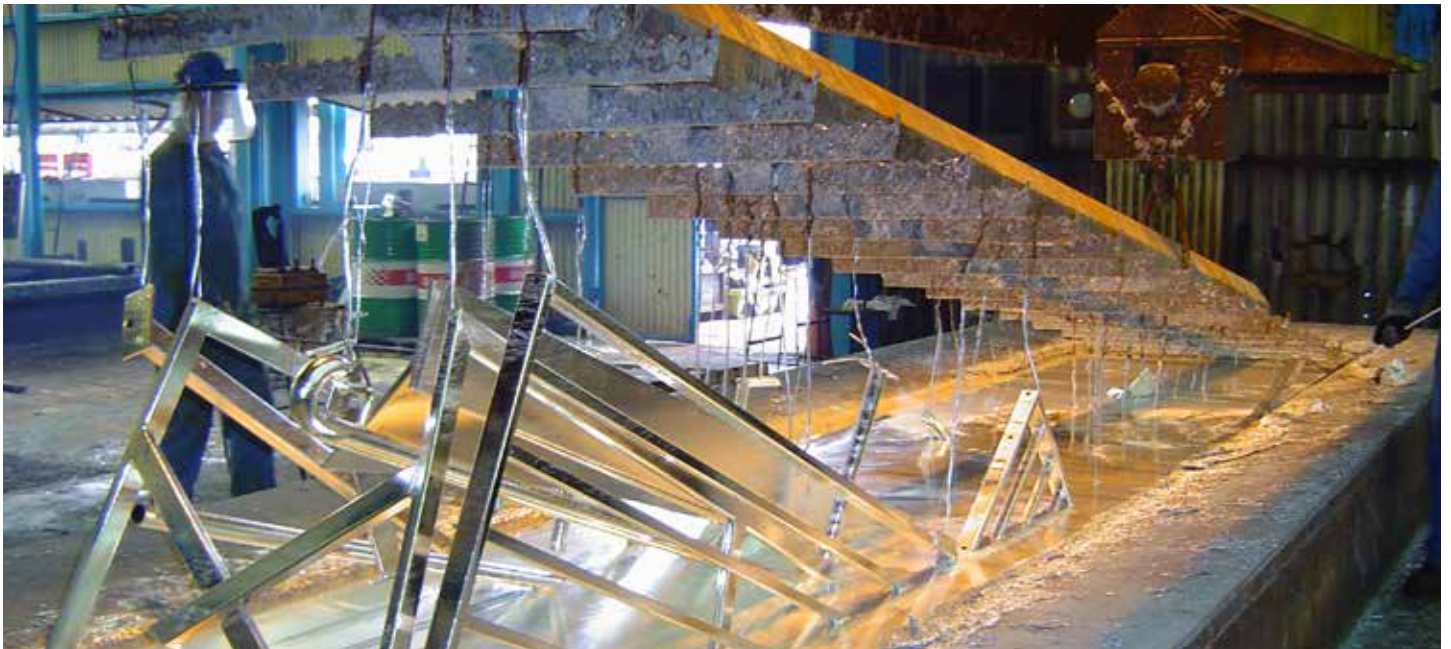
## Hot dip galvanizing process

The hot dip galvanizing process starts by suspending steel articles and dipping them into a series of cleaning baths. Once cleaned, the steel is lowered at an angle into a bath of molten zinc. Immersing the steel on an angle allows air to escape from vented tubular shapes or pockets that may be within the design and permits the molten zinc to displace the air. The steel reacts with the molten zinc to form the galvanized coating. After being withdrawn from the zinc, the final step in most hot dip galvanizing processes is a quench and passivate to promote passivation of the zinc surface.

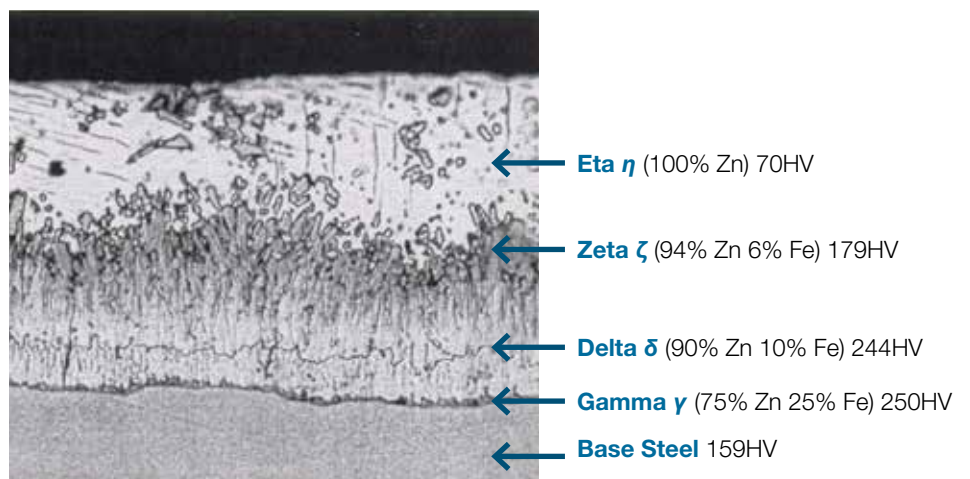
## Structure of coating

The formation of the galvanized coating on the steel surface is a metallurgical reaction, where the zinc and steel combine to form a series of hard intermetallic layers. The outer layer is, typically, 100% zinc which covers the surface after withdrawal from the molten zinc bath.

The gamma, delta and zeta alloy layers are all harder than the base steel they are metallurgically bonded to, which gives hot dip galvanizing its great abrasion resistance.

The galvanizing process naturally produces coatings on the corners and edges which are at least as thick as the coating on the rest of the article. As the reaction between iron and zinc is a diffusion reaction, the crystalline structure of the coating forms perpendicular to the steel surface.

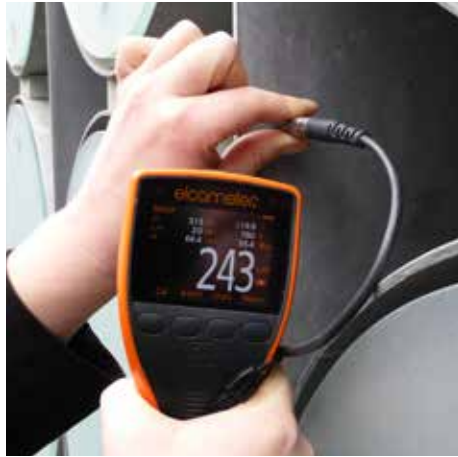
*Compliance to Standard is easily confirmed*

Inspecting galvanized steel is a simple process. Zinc will not adhere to or react with unclean steel; therefore, a visual inspection of the product provides a good assessment of the quality of the coating. The coating thickness is usually tested using a magnetic thickness gauge. The testing and sampling requirements are contained in the appropriate specification for the product (AS/NZS 4680 and AS 1214).

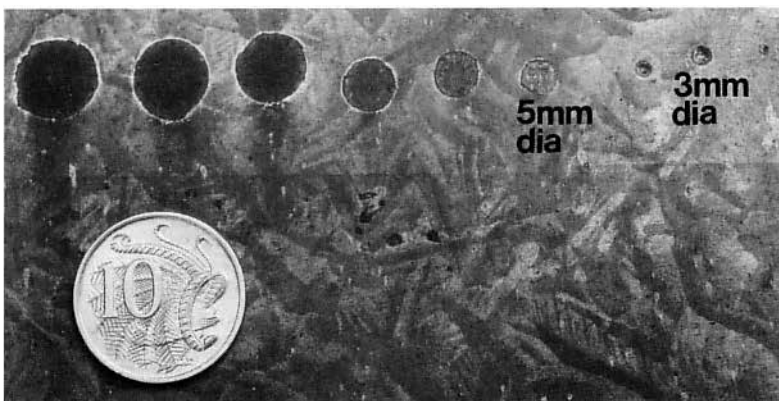
The galvanized steel test piece has had circular areas of the coating removed before exposure in a severe industrial environment. Sacrificial protection is provided by the surrounding galvanized coating and has prevented corrosion of the exposed circles up to 3mm diameter and minimised corrosion of the 5mm circle. Larger circles also exhibit corrosion-free annular areas adjacent to the surrounding coating.

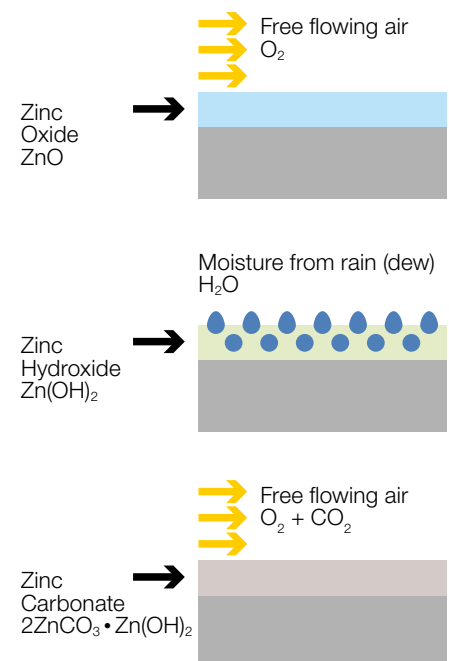
Above: The zinc patina begins its development with exposure to oxygen in the atmosphere. Moisture from rain or humid air reacts with this layer to form zinc hydroxide. This layer then reacts with carbon dioxide present in the atmosphere to form the tightly adherent, insoluble zinc patina.

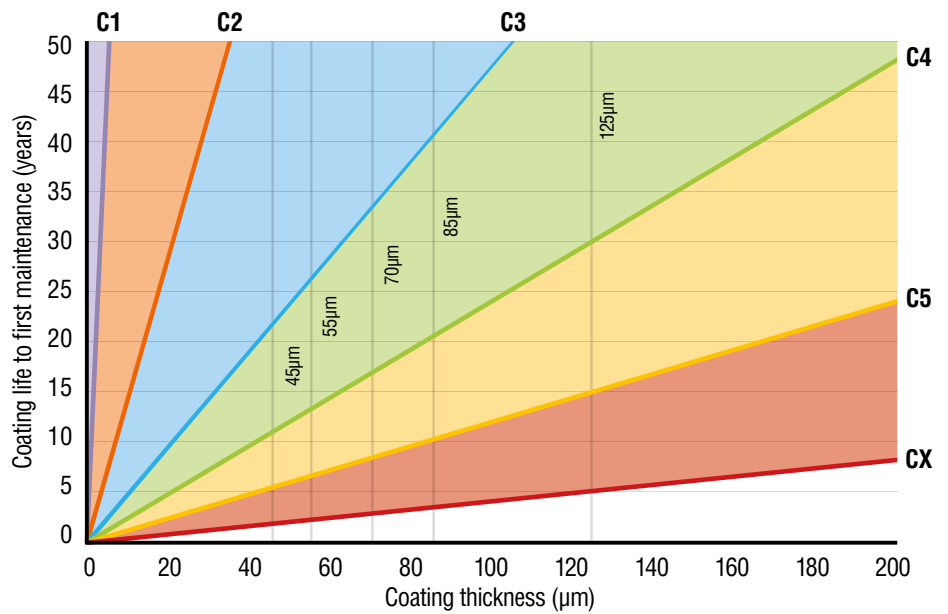
The chart shows that steel with an initial coating thickness of 85µm in a C4 corrosivity zone will have an expected life to first maintenance of 20 – 40 years.

Typical corrosivity categories and corrosion rates of steel and zinc				Typical service life (years) for hot dip galvanized articles to AS/NZS 4680				
Corrosivity category and typical environment		Corrosion rate (µm/year)		Fabricated article thickness (mm) and coating specification as per AS/NZS 4680				
				≤ 1.5	> 1.5 and ≤ 3.0	> 3.0 and ≤ 6.0	> 6.0	>> 6.0*
		Mild steel	Zinc	45 µm 320 g/m <sup>2</sup>	55 µm 390 g/m <sup>2</sup>	70 µm 500 g/m <sup>2</sup>	85 µm 600 g/m <sup>2</sup>	125 µm* 900 g/m <sup>2</sup>
C1	Dry indoors	≤1.3	≤0.1	100+	100+	100+	100+	100+
C2	Arid/Urban inland	>1.3 to ≤25	>0.1 to ≤0.7	64-100+	78-100+	100+	100+	100+
C3	Coastal or industrial	>25 to ≤50	>0.7 to ≤2.1	21-64	26-78	33-100	40-100+	60-100+
C4	Calm sea-shore	>50 to ≤80	>2.1 to ≤4.2	11-21	13-26	17-33	20-40	30-60
C5	Surf sea-shore	>80 to ≤200	>4.2 to ≤8.4	5-11	7-13	8-17	10-20	15-30
CX	Off-shore	>200 to ≤700	>8.4 to ≤25	2-5	2-7	3-8	3-10	5-15
